Sidewalk Grading Report

City of Washington, GA

Prepared by Tiffany Oden

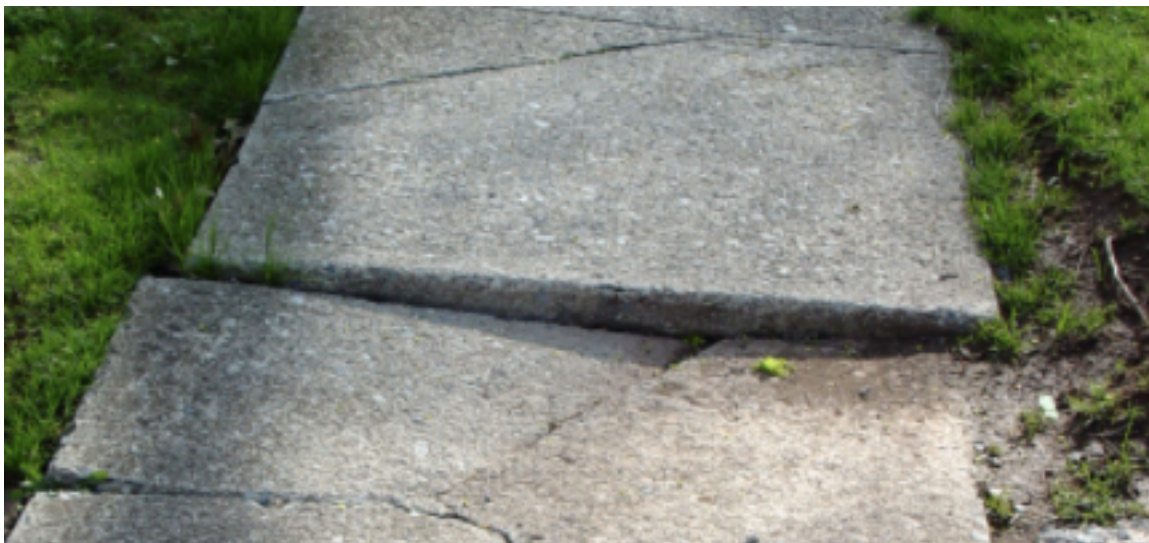
Faulting (WILL BE CODED ON MAPS AS “A”): can run be minor (as defined in this report as one slab being roughly 2 inches or less in height difference to an adjacent slab), or can be major (2 inches or more in height differences between two adjacent slabs)

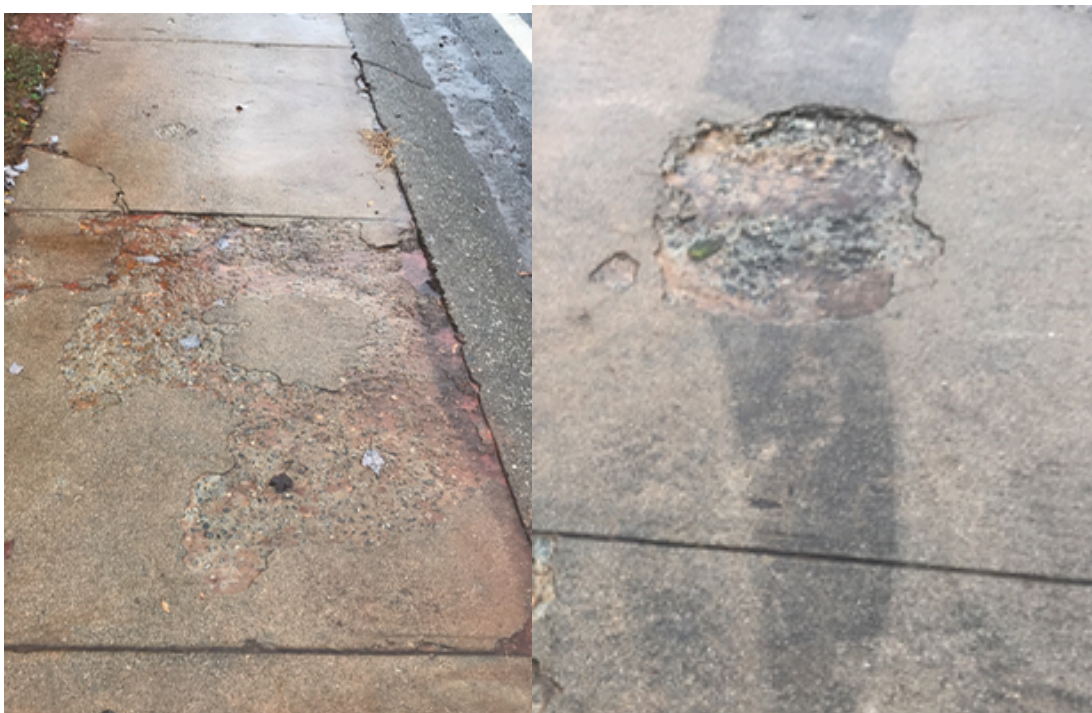
Spalling (WILL BE CODED ON MAPS AS “B”): occurs when weather and overuse has caused the smooth surface of the slab to deteriorate

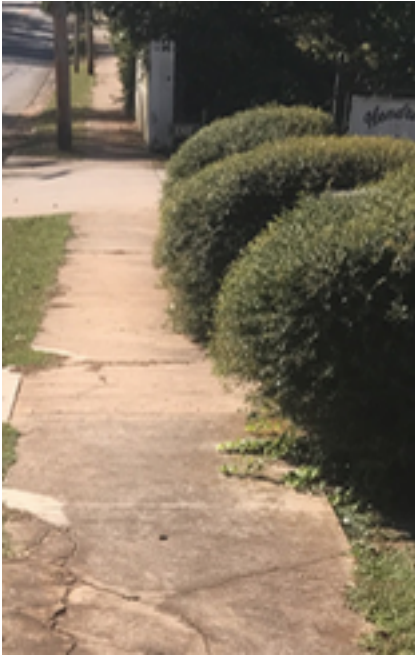
Obstruction (WILL BE CODED ON MAPS AS “C”): overgrown trees/shrubs encroaching on the sidewalk and limiting is walkability

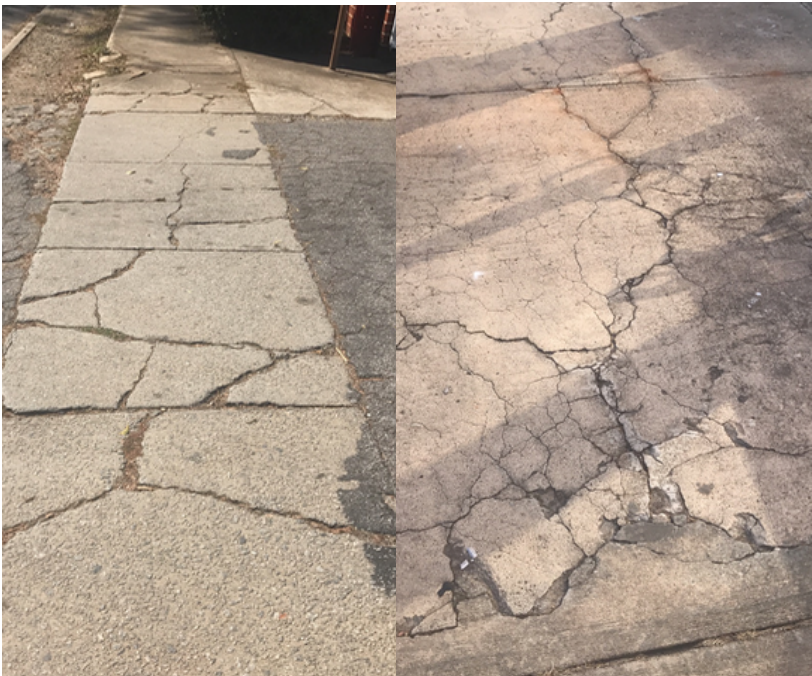
Cracking (WILL BE CODED ON MAPS AS “D”):

****Can be minor such as one hairline crack, or major cracking like the above examples.**

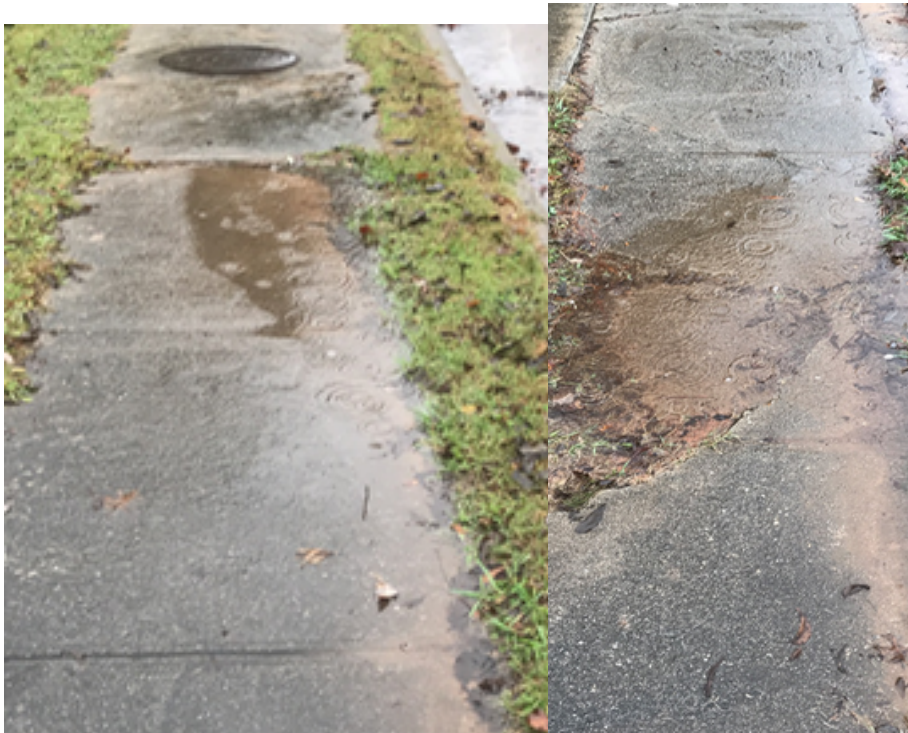
Ponding (WILL BE CODED ON MAPS AS A “E”): occurs when depressions in the sidewalk slabs cause puddling on sidewalks after storms

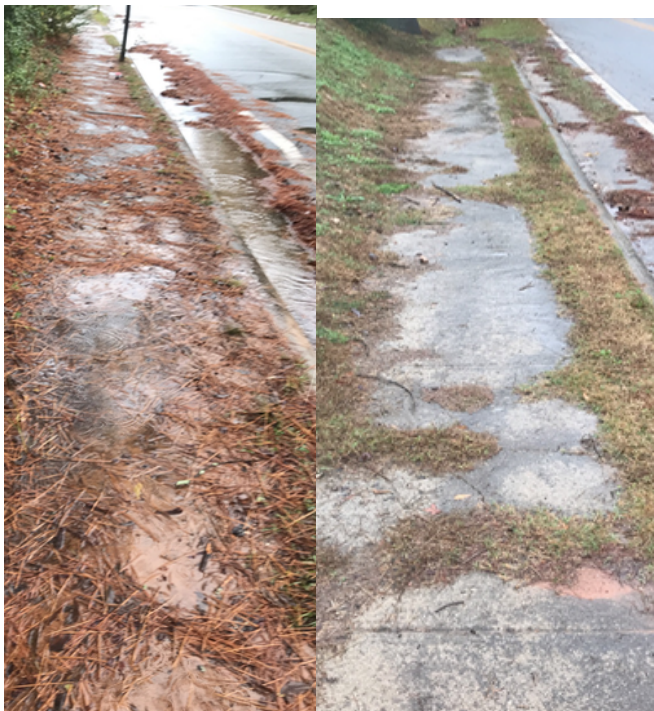
Cleanliness (WILL BE CODED ON MAPS AS A “F”): caused by excessive debris (left picture) or grassy overgrowth between cracks and slabs (right picture)

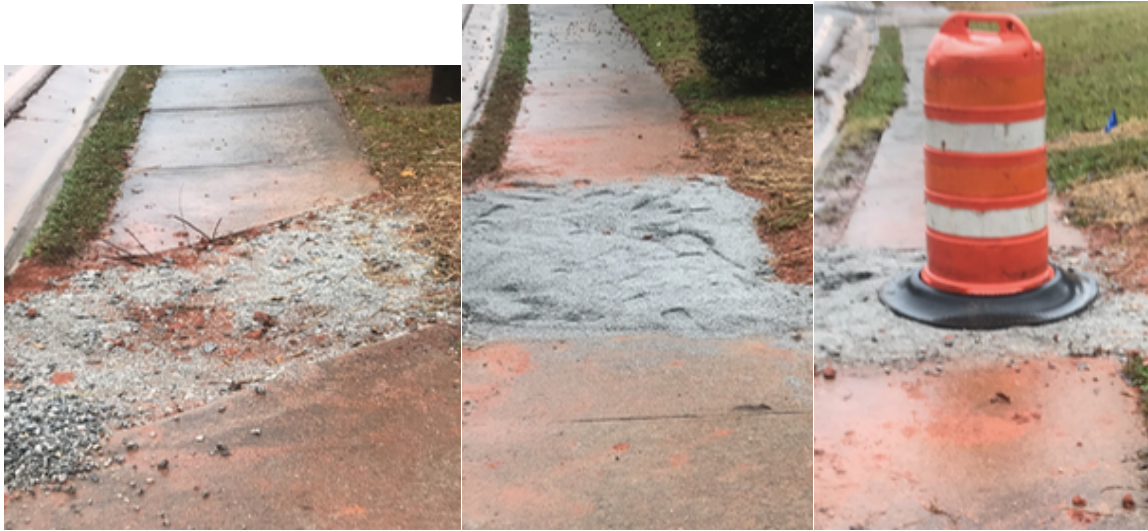
Missing slabs (WILL BE CODED ON MAPS AS “G”):

****While the above examples are areas where a full slab is missing, there can also be pieces of the slab missing leaving a partial slab in tact.**

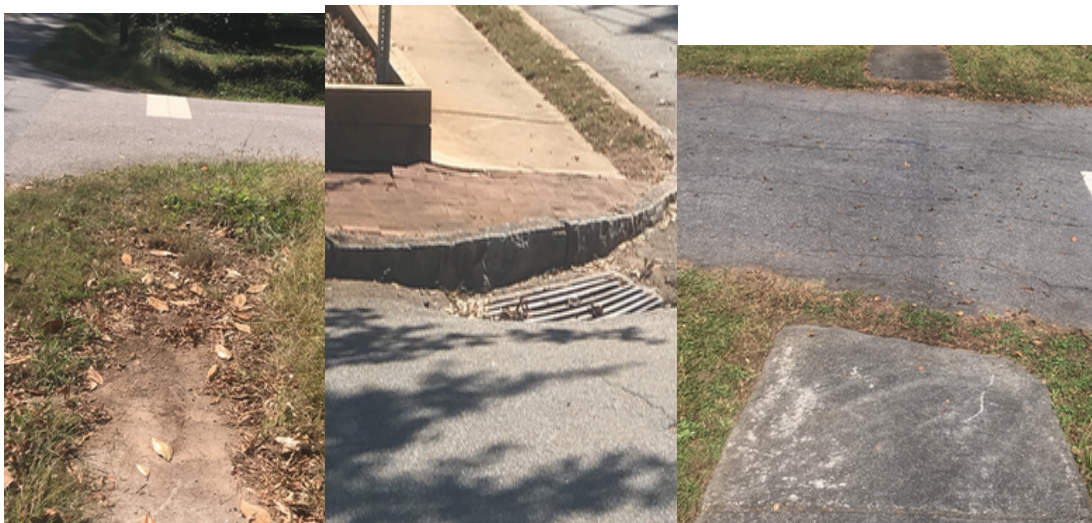
Non-ADA compliant curb endings (WILL BE NOTATED FOR EACH REGION WHERE NON-ADA CURBS FOUND) occurs where there is either no sloped curb cut or a random end to the sidewalk prior to reaching a street where the sidewalk would naturally end

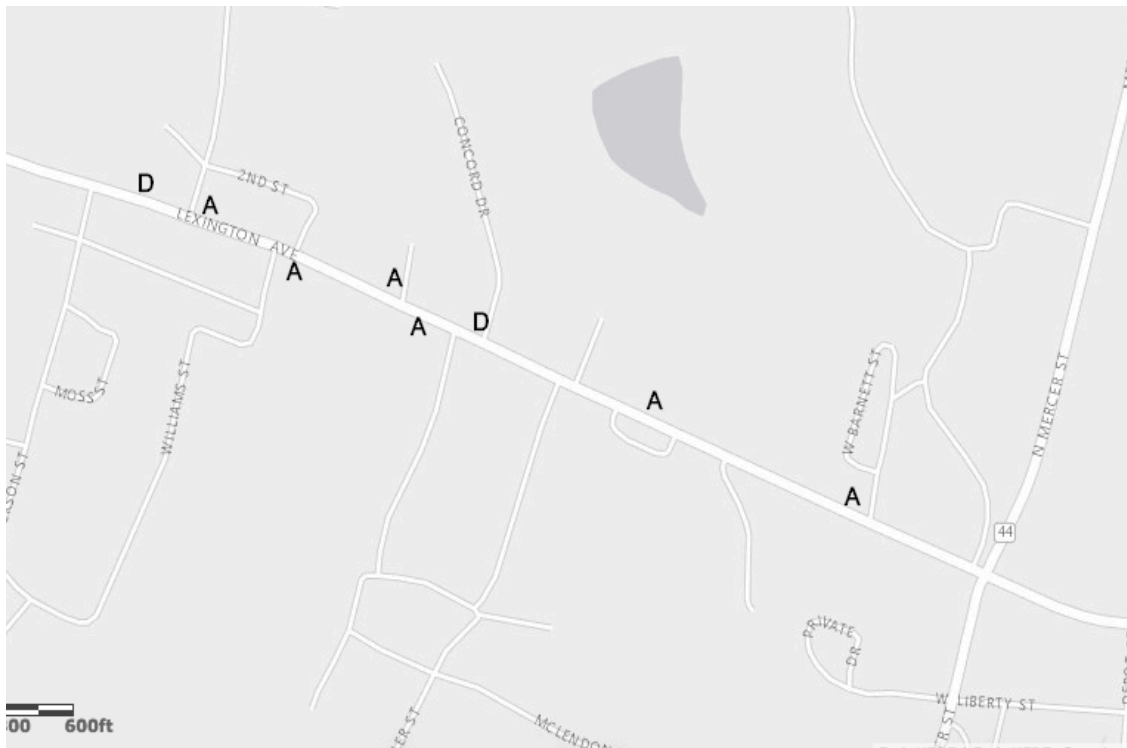
**Sidewalk Region Being Examined:
Region 1 (Lexington Ave)**

OVERALL GRADE: 4

Problem	Number of Areas Observed with Problem in Region Examined
Major Cracking (Coded as "D")	2
Major Faulting (Coded as "A")	6

****Almost all curbs in the area are Non-ADA compliant**

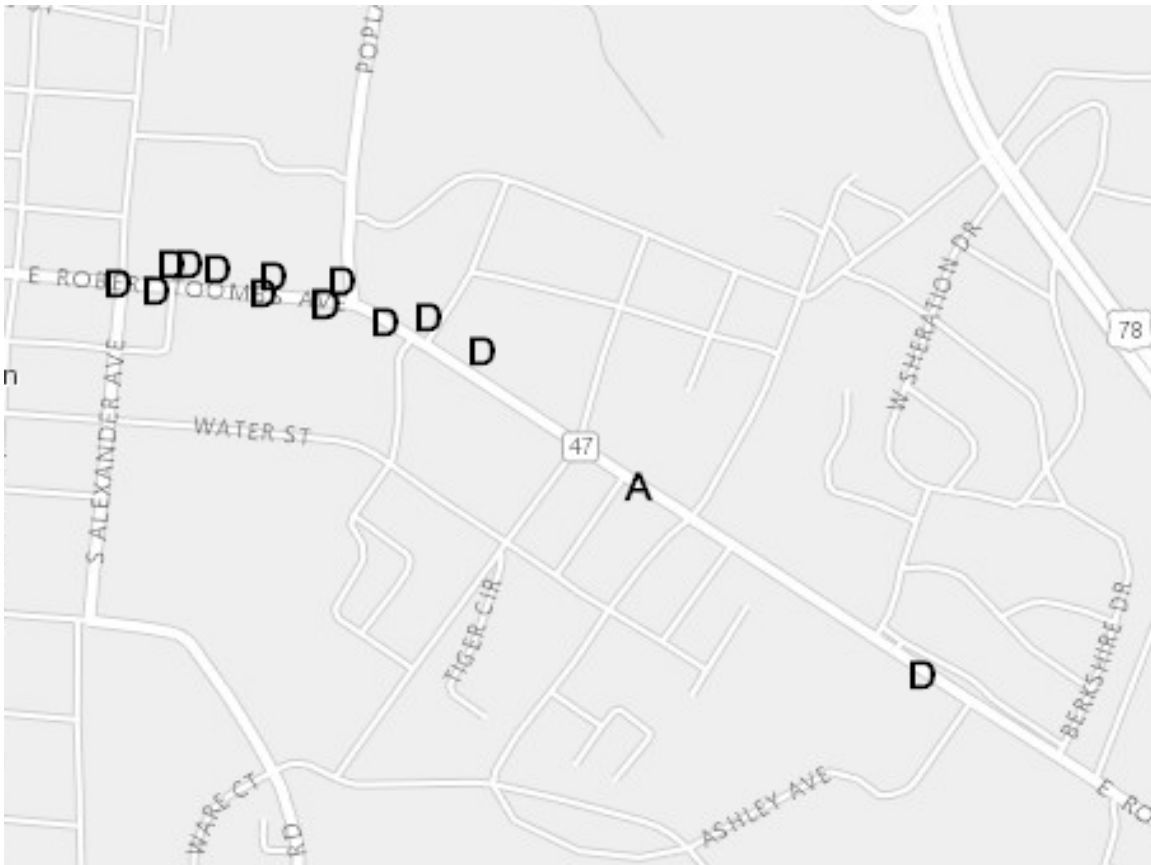
**Sidewalk Region Being Examined:
Region 2 (E. Robert Toombs)**

OVERALL GRADE: 3

Problem	Number of Areas Observed with Problem in Region Examined
Major Cracking (Coded as "D")	13
Major Faulting (Coded as "A")	1

****At least 6 curb endings in area are Non-ADA compliant**

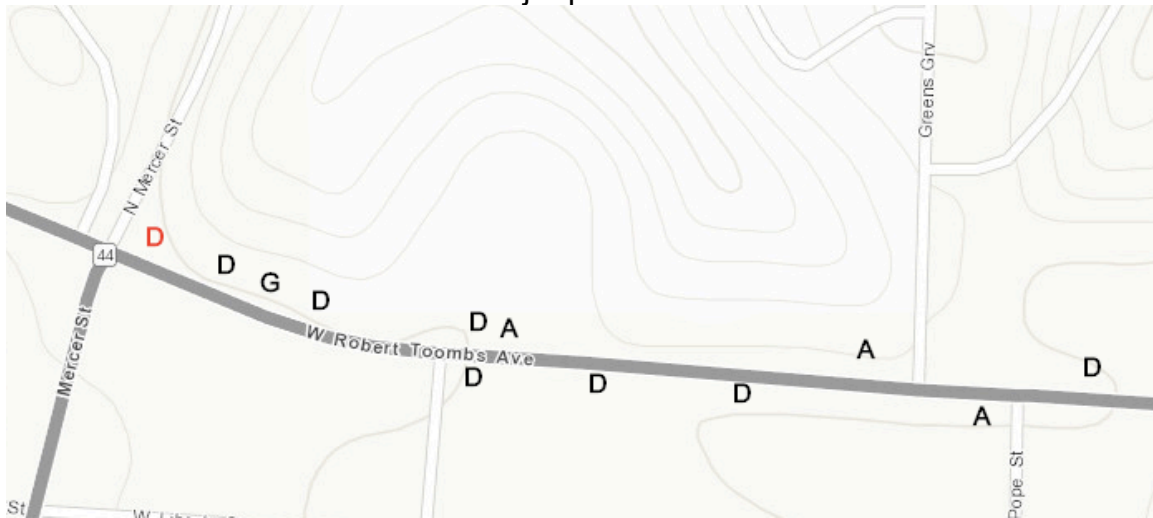
Sidewalk Region Being Examined:
Region 3 (W. Robert Toombs & small side streets shown on regions map)
OVERALL GRADE: 3

Problem	Number of Areas Observed with Problem in Region Examined
Major Cracking (Coded as "D")	8
Major Faulting (Coded as "A")	3
Missing Slab (Coded as "G")	1

**One D is colored in red because this area needs immediate attention (shown on next page)

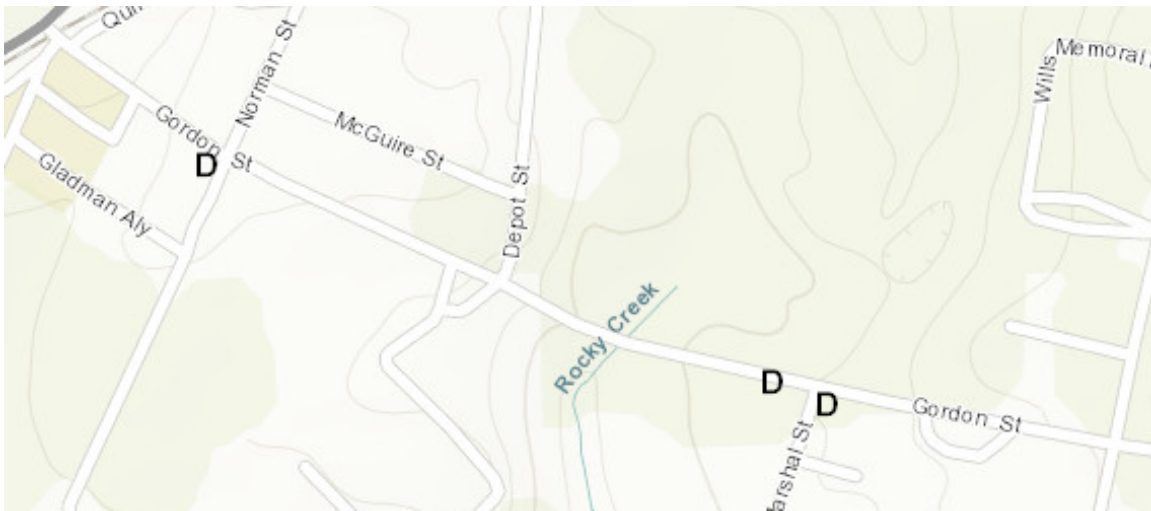
**Sidewalk Region Being Examined:
Region 4 (Gordon Street)**

Problem	Number of Areas Observed with Problem in Region Examined
Major Cracking (Coded as "D")	3

****4 areas noted to be have non-ADA compliant curb endings or random sidewalk endings prior to reaching a cross street**

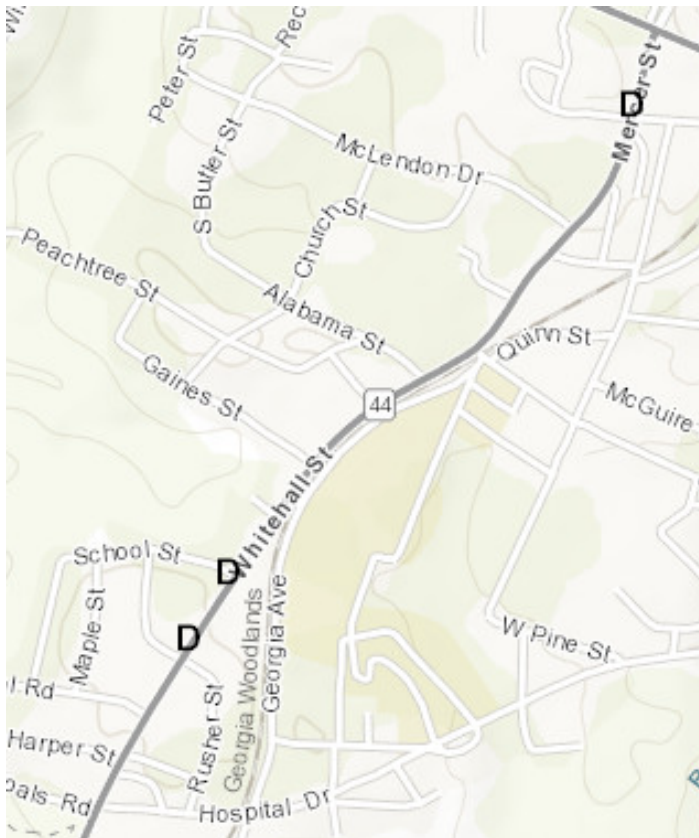
**Sidewalk Region Being Examined:
Region 5 (Whitehall St)**

Problem	Number of Areas Observed with Problem in Region Examined
Major Cracking (Coded as "D")	3

****Area is mostly prevalent with minor cracking, areas of major cracking are not severe enough to warrant immediate attention.**

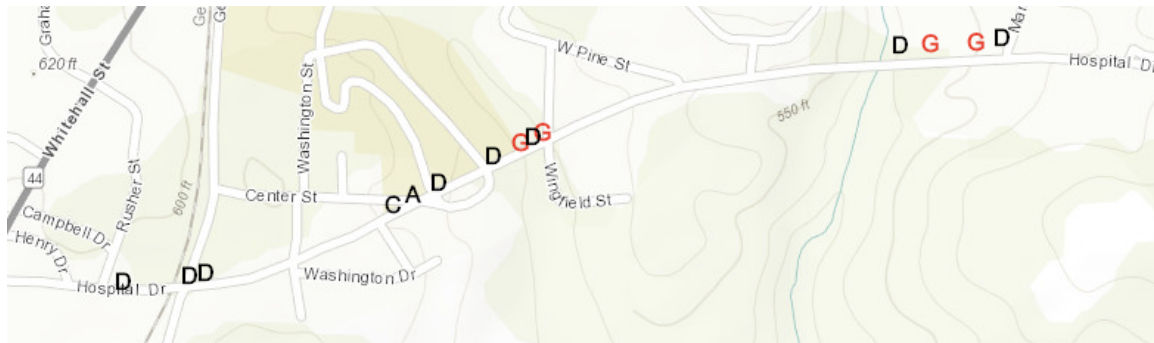
**Sidewalk Region Being Examined:
Region 6 (Hospital Drive)**

Problem	Number of Areas Observed with Problem in Region Examined
Major Cracking (Coded as "D")	8
Major Faulting (Coded as "A")	1
Missing Slab (Coded as "G")	4
Major Obstruction (Coded as "C")	1

****All areas with missing sidewalks are listed in red, because these areas need sidewalk slabs replaced immediately (see pictures on next page)**

****10 areas marked with non-ADA compliant curb endings on Hospital Dr**

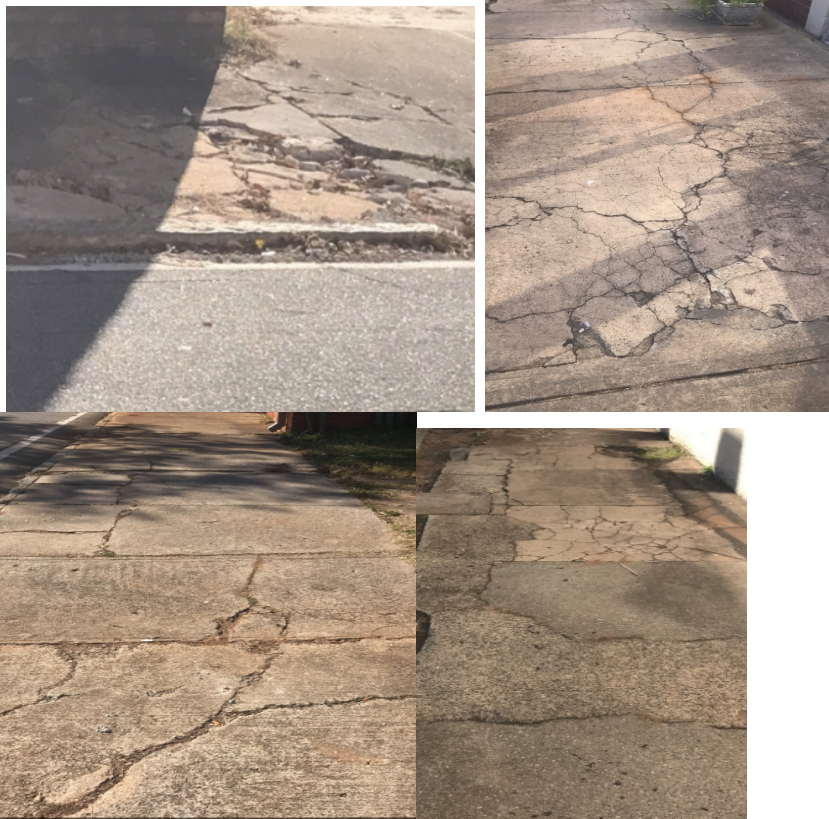
**Sidewalk Region Being Examined:
Region 8 (N. Jefferson St)**

Overall Grade: 1

Entirety of N. Jefferson St (sidewalk area) is rife severe with cracking, will require immediate repairs (see below)

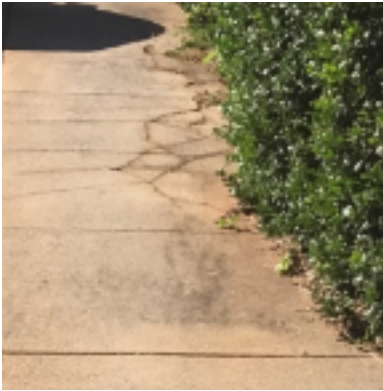
Problem	Number of Areas Observed with Problem in Region Examined
Minor Cracking	2

(at back/side of courthouse)

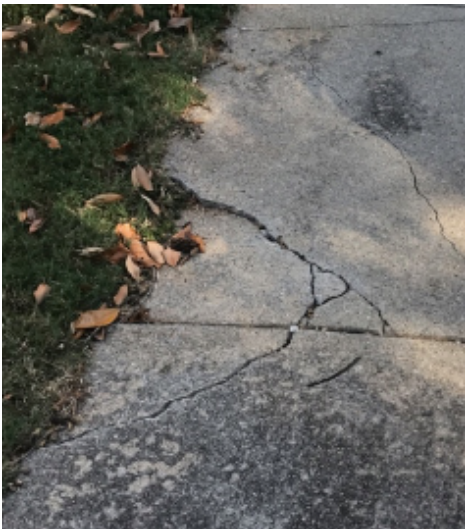
(at front of courthouse)

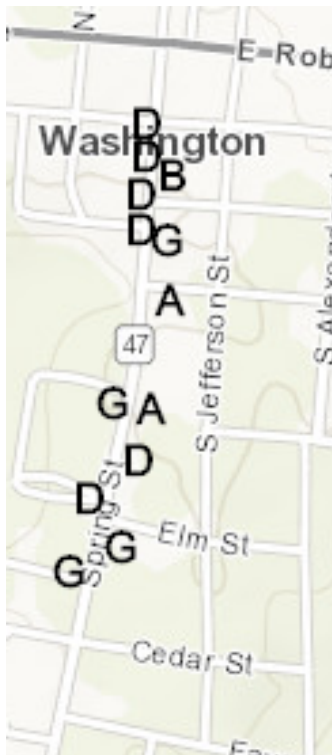
**Sidewalk Region Being Examined:
Region 10 (Spring St)**

Problem	Number of Areas Observed with Problem in Region Examined
Major Cracking (Coded as "D")	6
Major Faulting (Coded as "A")	2
Missing Slab (Coded as "G")	4
Major Spalling (Coded as "B")	1

** At least 3 Curbs in area are non-ADA compliant

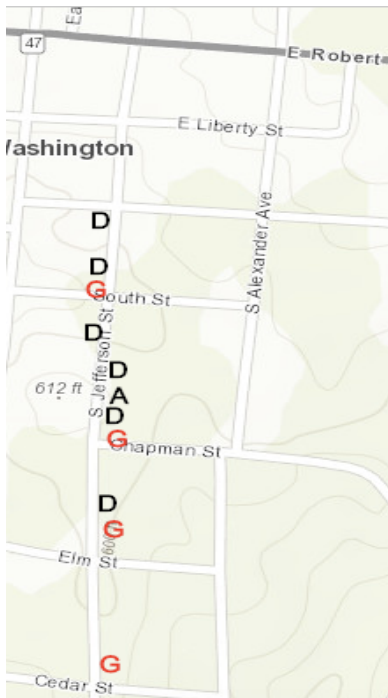
**Sidewalk Region Being Examined:
Region 11 (Jefferson St)**

Problem	Number of Areas Observed with Problem in Region Examined
Major Cracking (Coded as "D")	6
Major Faulting (Coded as "A")	1
Missing Slab (Coded as "G")	4

**Areas marked in red present serious issues that need to attention

**At least 6 curb endings in area are non-ADA compliant

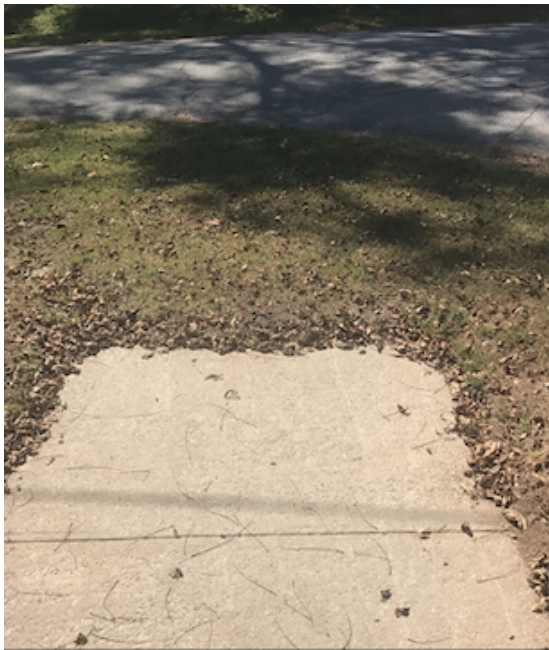
Curb end Jefferson and cedar

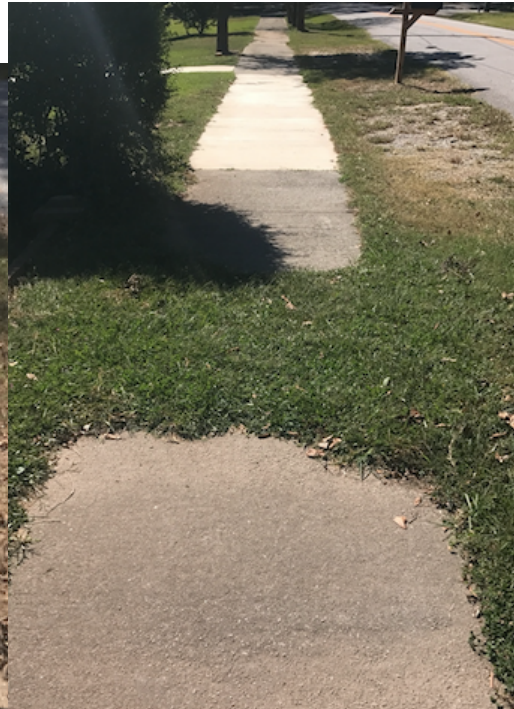
Missing slab between 509 and 513 Jefferson

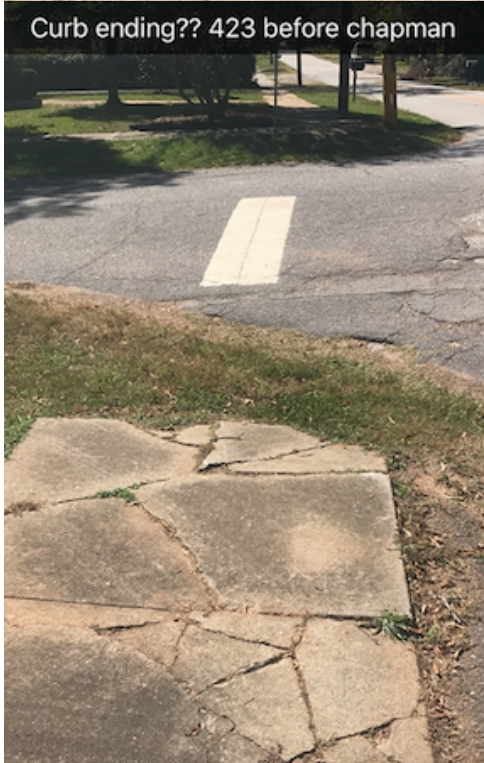
Curb ending?? 423 before chapman

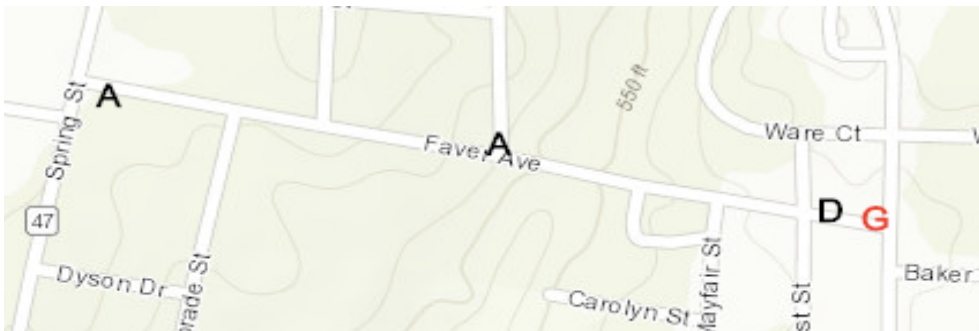
**Sidewalk Region Being Examined:
Region 12 (Faver Ave.)**

Problem	Number of Areas Observed with Problem in Region Examined
Major Cracking (Coded as "D")	1
Major Faulting (Coded as "A")	2
Missing Slab (Coded as "G")	1

**Area marked as "G" is non-ADA compliant curb ending, needs another slab to reach the street (see picture below map)

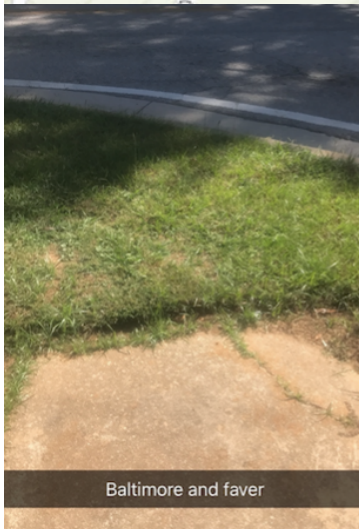
**Picture of "G" as marked on map

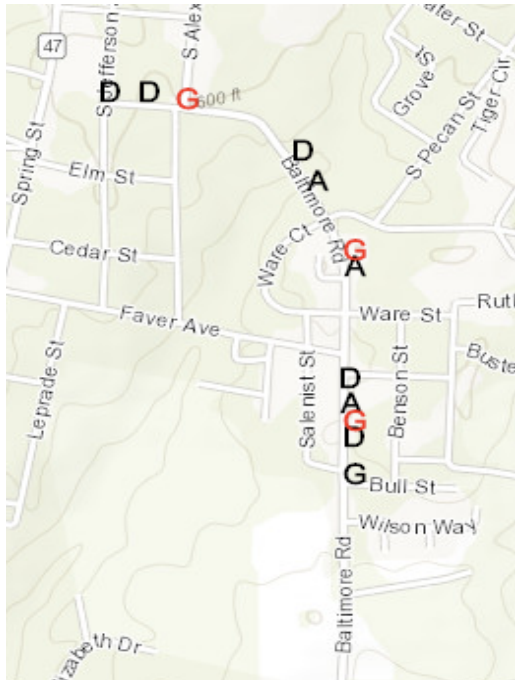
**Sidewalk Region Being Examined:
Region 13 (Baltimore Rd/Chapman)**

Problem	Number of Areas Observed with Problem in Region Examined
Major Cracking (Coded as "D")	5
Major Faulting (Coded as "A")	3
Missing slab (Coded as "G")	4

****Areas listed in red represent areas/slabs that need immediate attention (see next page)**

****At least 9 curb endings non-ADA compliant**

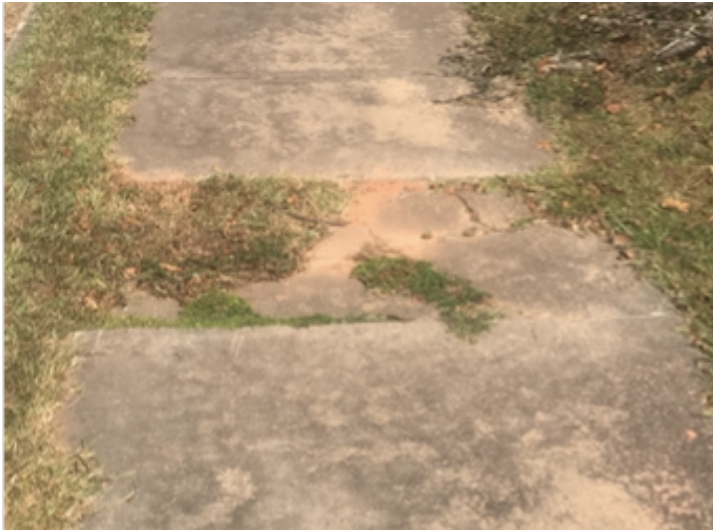
Collapsed slab

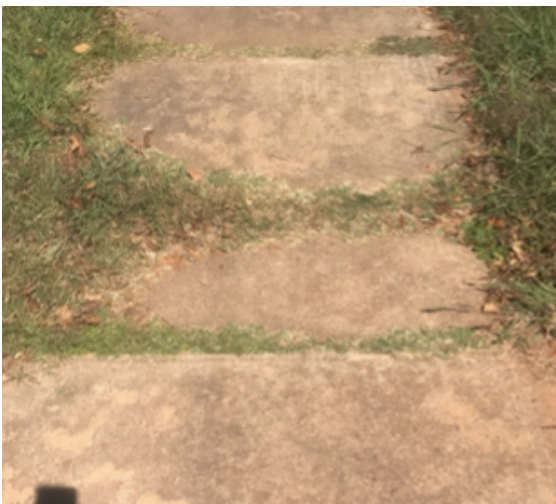
Collapsed slab

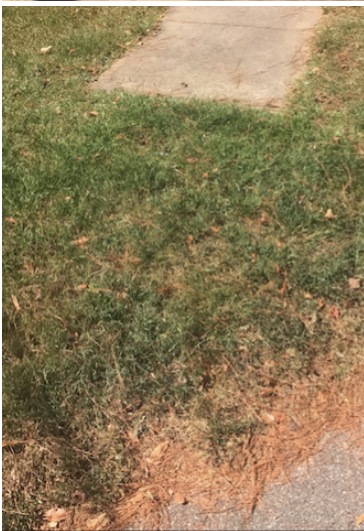
random sidewalk ending/slab missing

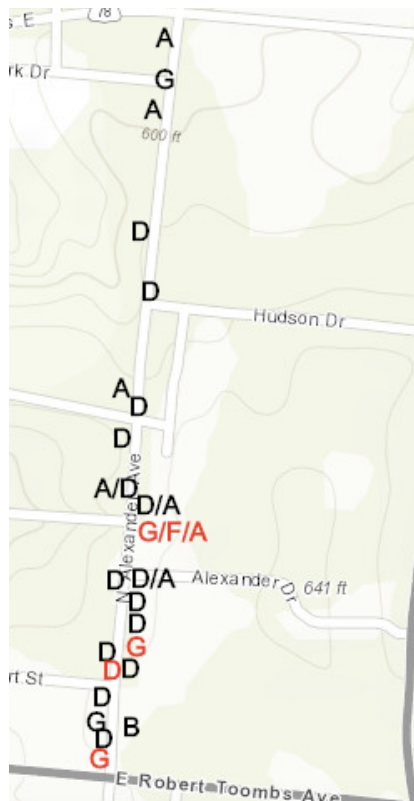
**Sidewalk Region Being Examined:
Region 15 (N. Alexander)**

Problem	Number of Areas Observed with Problem in Region Examined
Major Cracking (Coded as "D")	15
Major Faulting (Coded as "A")	7
Missing Slab (Coded as "G")	5
Major Spalling (Coded as "B")	1
Major Cleanliness (Coded as "F")	1

****Areas in red require immediate attention (pictures shown on next page)**

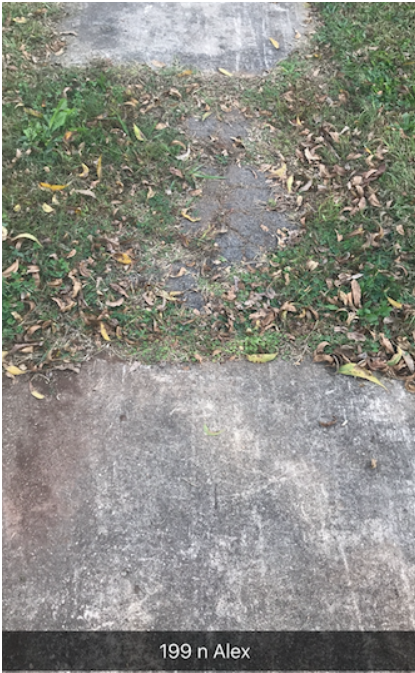
199 n Alex

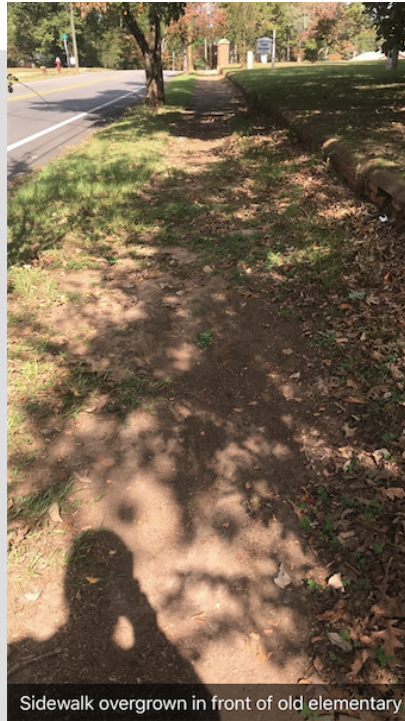
Sidewalk overgrown in front of old elementary

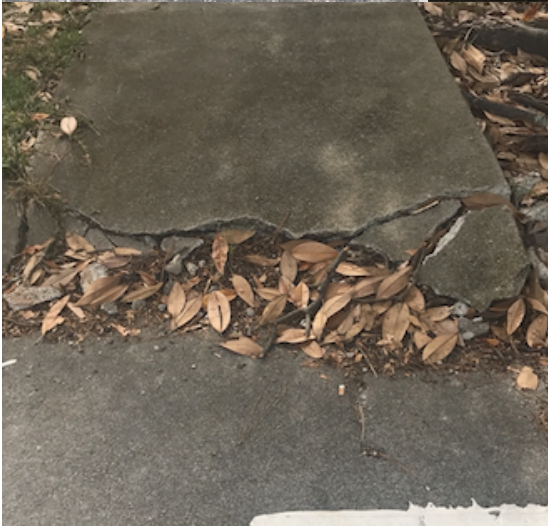
Dangerous curb ending by US post office

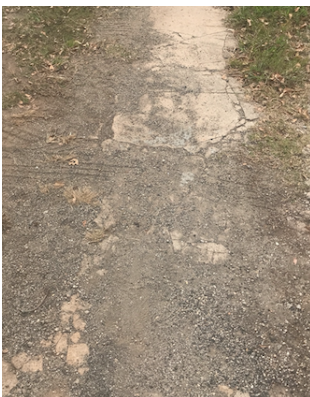
Sidewalk completely decaying at intersection of Robert Toombs and N. Alexander

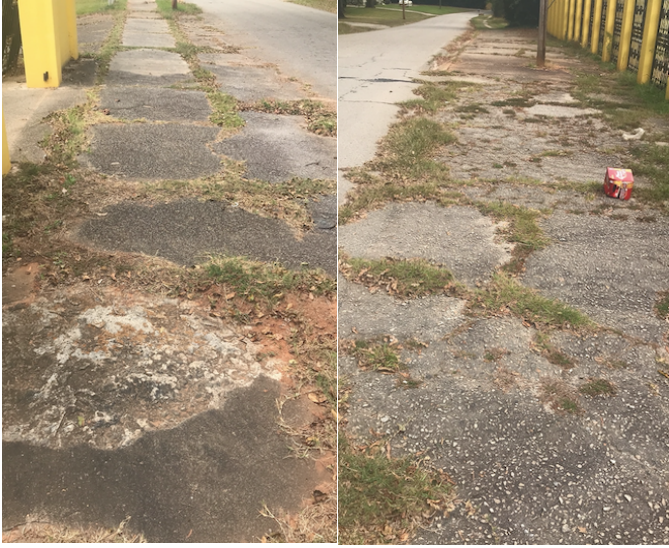
Spalling/Cracking

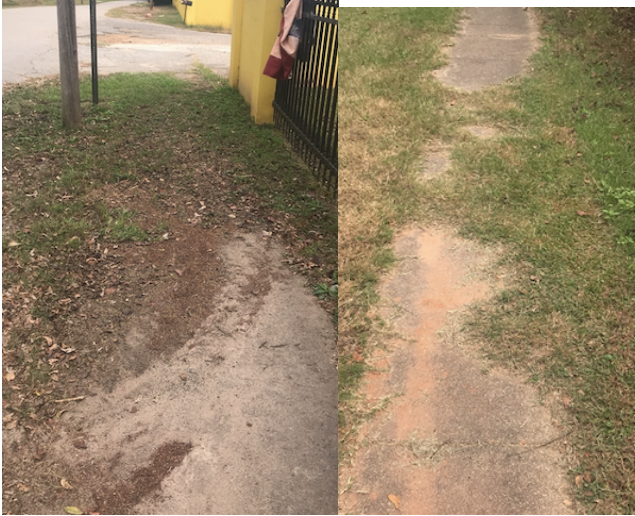
No curb ending & severe overgrowth

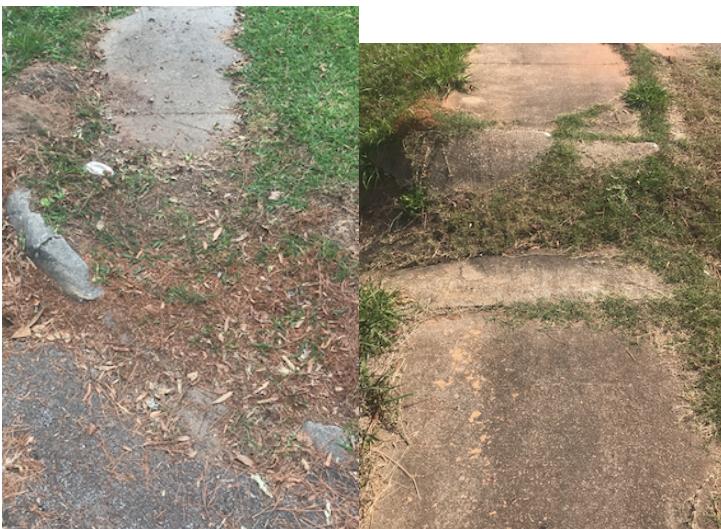
No curb ending & slab completely caving in

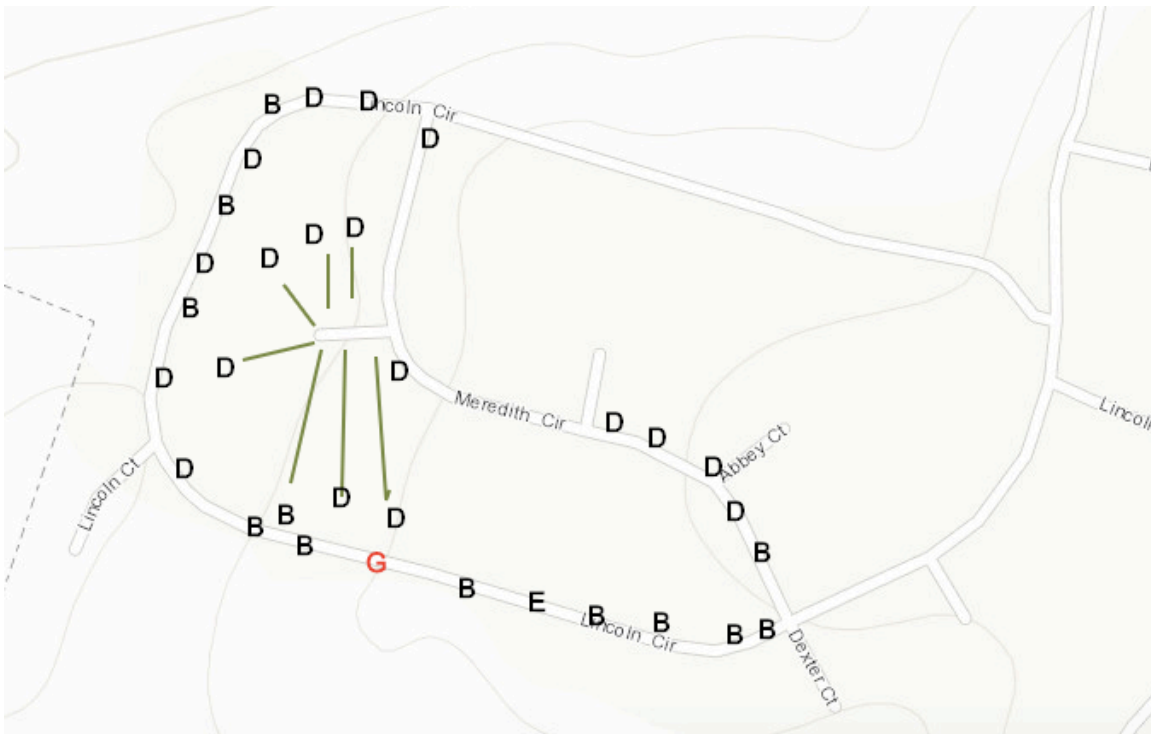
**Sidewalk Region Being Examined:
Region 17 (Lincoln Cir. & Meredith Cir.)**

Problem	Number of Areas Observed with Problem in Region Examined
Major Cracking (Coded as "D")	18
Missing Slab (Coded as "G")	1
Major Spalling (Coded as "B")	12
Major Ponding (Coded as "E")	1

**Only one pressing issue notated in red, shown on next page

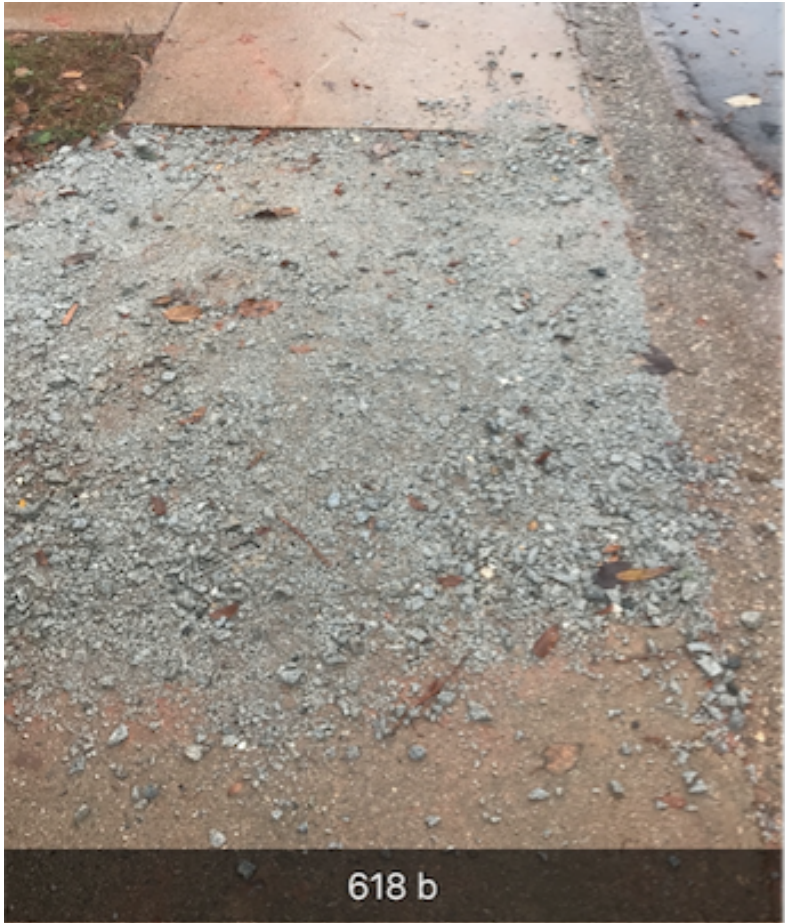
Missing slab located near home 618B

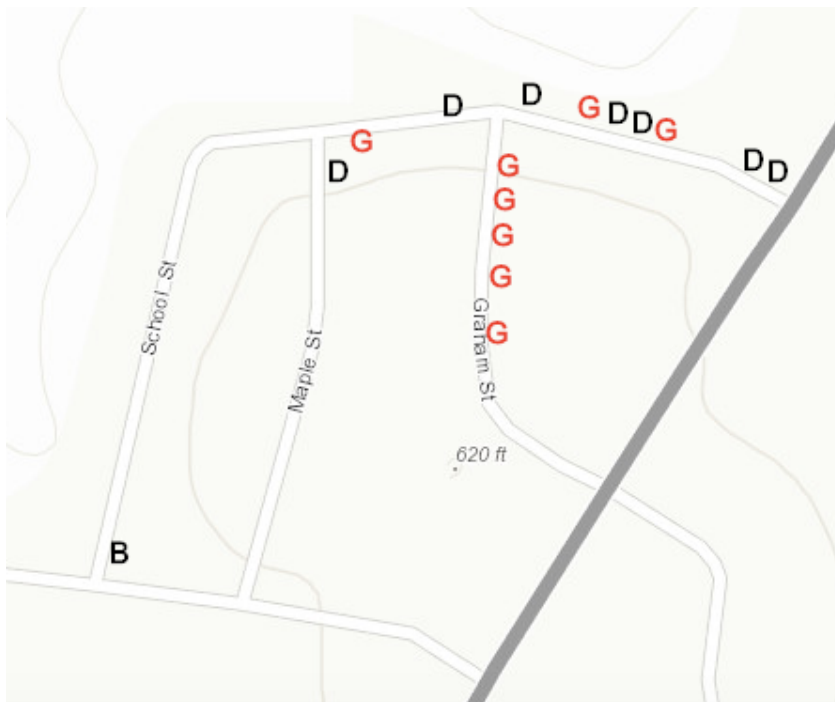
**Sidewalk Region Being Examined:
Region 18 (School & Graham)**

Problem	Number of Areas Observed with Problem in Region Examined
Major Cracking (Coded as "D")	7
Missing Slab (Coded as "G")	8
Major Spalling (Coded as "B")	1

****Serious issues marked in red can be viewed on next page**

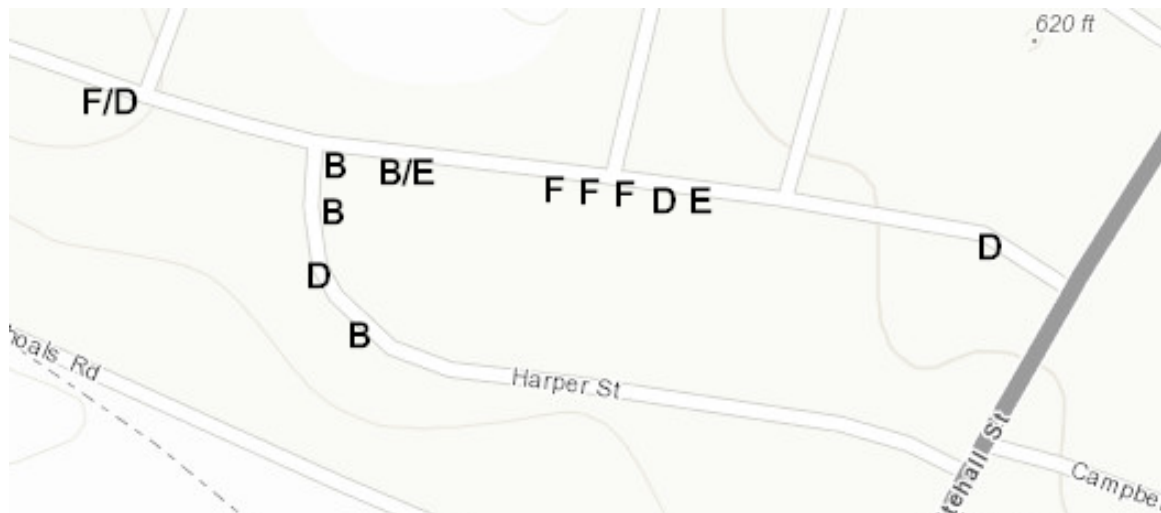
Sidewalk Region Being Examined:
Region 19 (Old Skull Shoals Rd/ Harper St)
OVERALL GRADE: 2

Problem	Number of Areas Observed with Problem in Region Examined
Major Cracking (Coded as "D")	4
Major Spalling (Coded as "B")	4
Major Ponding (Coded as "E")	2
Major Cleanliness (Coded as "F")	4

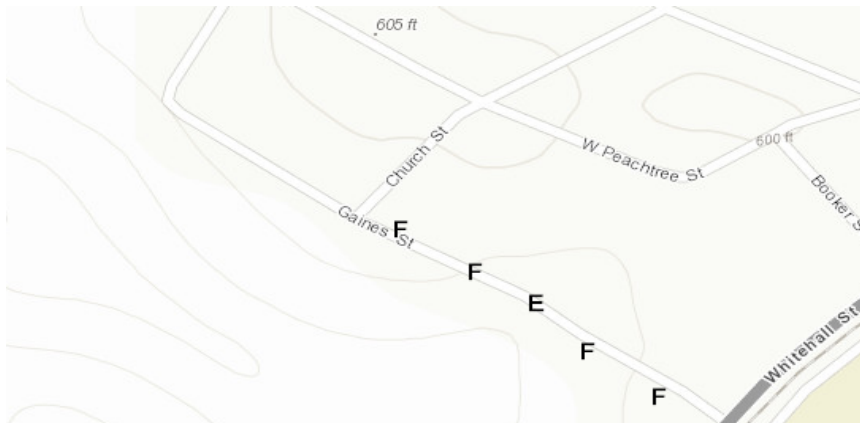
**Sidewalk Region Being Examined:
Region 21 (Gaines St)**

Problem	Number of Areas Observed with Problem in Region Examined
Major Ponding (Coded as "E")	1
Major Cleanliness (Coded as "F")	4

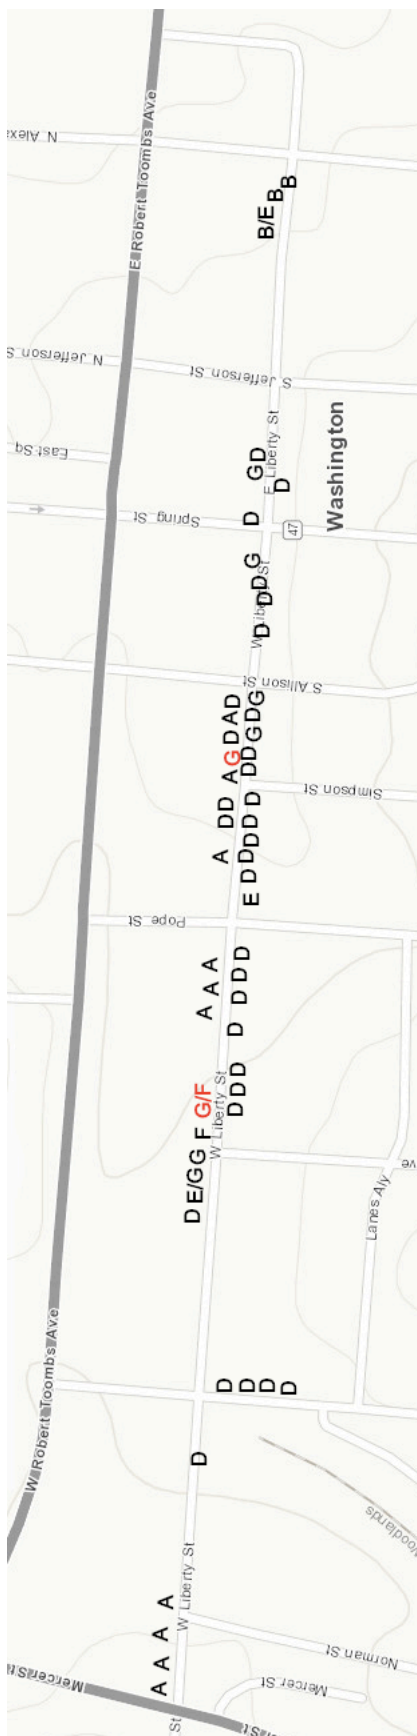
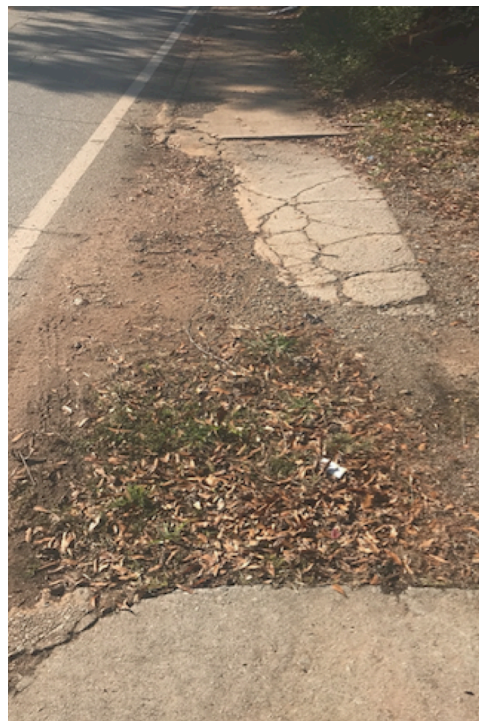
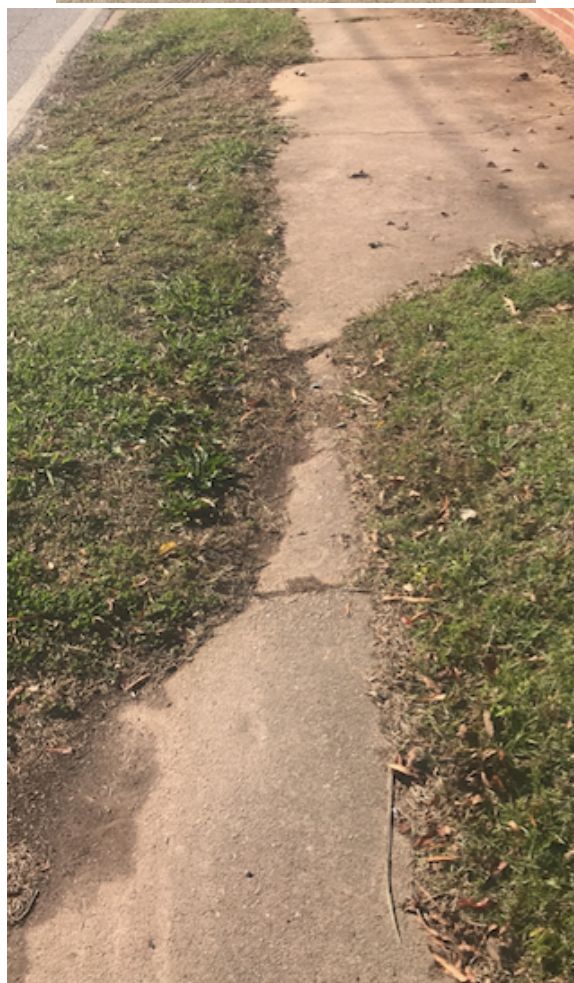
**Sidewalk Region Being Examined:
Region 22 (Liberty St)**

Problem	Number of Areas Observed with Problem in Region Examined
Major Cracking (Coded as "D")	31
Major Faulting (Coded as "A")	10
Slab Missing (Coded as "G")	8
Major Spalling (Coded as "B")	3
Major Ponding (Coded as "E")	3
Major Cleanliness (Coded as "F")	2

**Serious issues marked in red will be shown to the right of the map on page below

**At least 10 curbs in area shown to be non-ADA compliant
